# Restoring a... Georgian desk

**Chris Tribe repairs the flap, replaces cockbeading, restores the sides and sorts out the rail jointing**

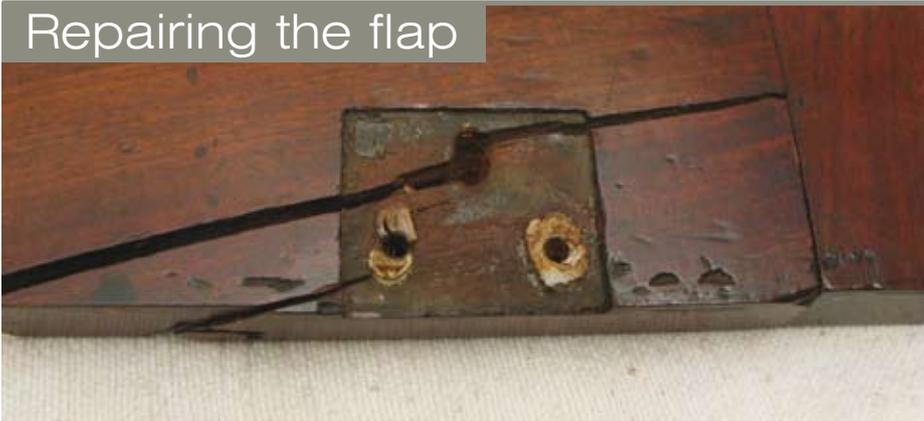
1 Damage to left hand of flap; note worn screw holes

The flap had broken at the hinge on the left and the hinge had broken from the interior on the right. There had been a previous breakage at this point – repaired with a nail, *photo 1*. This meant that the break was not clean so the repaired fit would not be perfect.

After removing the nail the broken piece was carefully cleaned of old glue using meths and warm water, then glued and clamped into place.

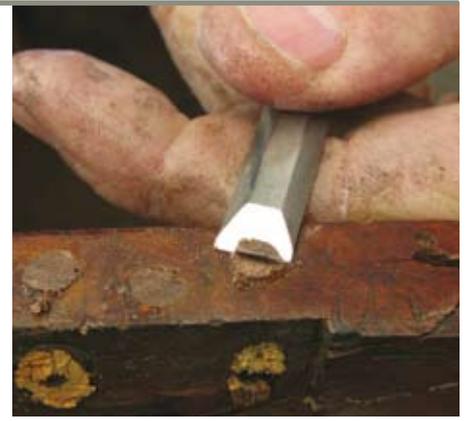
One of the hinge screw holes was on the line of the break so there was a danger of the repair being weakened when the screw was replaced. All the screw holes were badly worn and had been plugged, so 6mm dowels were inserted from the edge of the flap to coincide with the position of the screws and then trimmed off with a chisel, *photo 2*.

2 Trimming off the dowels inserted to strengthen repair to left of flap

This helped to stabilise the repair and gave more for the screws to bite into than inserting a dowel into the screw hole. When in position the edge of the flap is angled downwards, so the dowels are not evident.

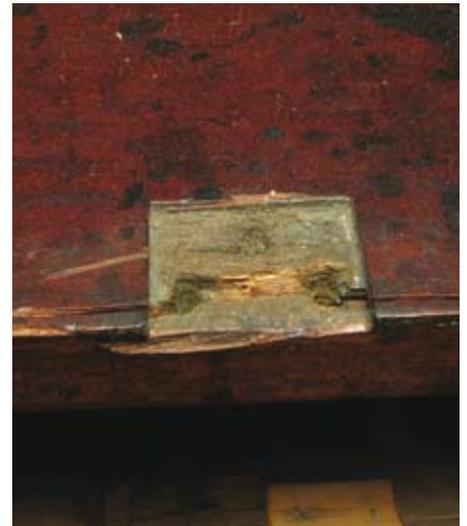
At the other hinge point the damage was to the interior. The break had occurred at the line of the two front screws of the

hinge, breaking away the 4mm-thick mahogany lipping and some of the oak substrate, *photo 3*.

3 Damage to hinge point at right side

I decided to recess a new piece of oak underneath the veneered surface. This meant using the router running on the edge of the board, a tricky operation requiring packing and jiggging.

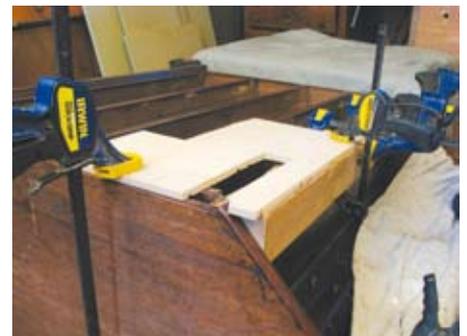
4 Preparation for cutting recess to repair broken hinge area

To provide a stable surface for the router to run on, a piece of 9mm MDF with a hole in it to provide access to the area to be cut was clamped to the front of the bureau, *photo 4*. A replacement piece was cut with angled ends and fitted by trial and error to the cleaned up recess, *photo 5*. Because of damage round the screw holes the area around them was replaced, *photo 6*.

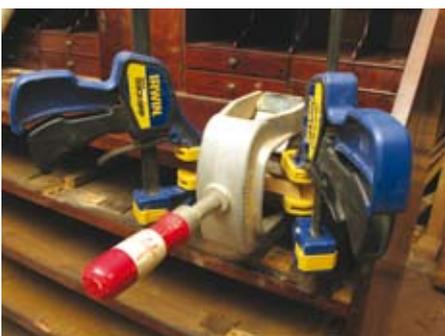
5 Clamping on the replacement

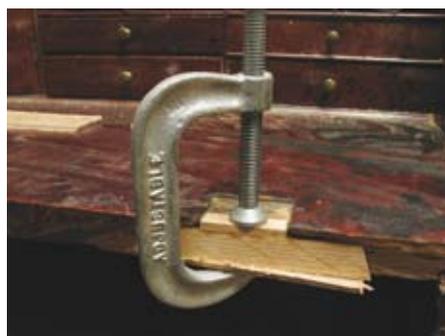
6 Clamping additional piece around screw area

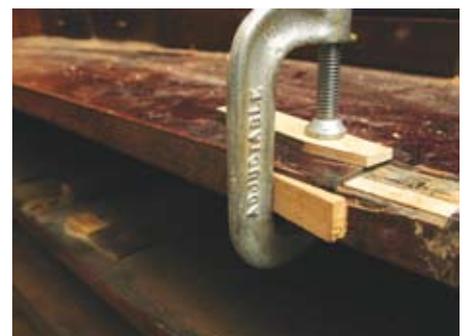
Some of the substrate behind the 4mm lipping had broken away so I ensured that the piece fitted snugly around the previously fitted oak piece, clamping with a small G-clamp and an oak wedge, *photo 7*, then replaced a small strip of veneer adjacent to the hinge.

7 Improvised edge clamp

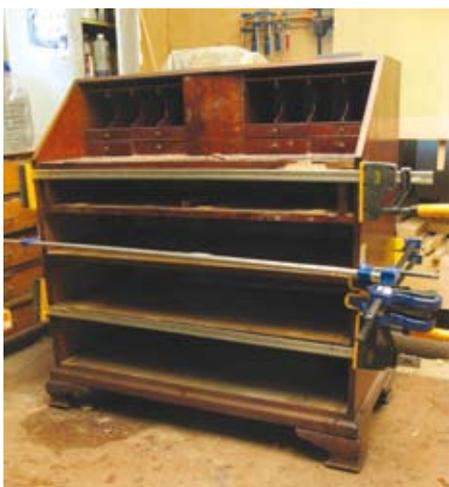
8 Clamping the injected rail joints

The fit of the drawers was slack, vertically due to wear in the drawer bottoms and running surfaces and horizontally due to the sides detaching from the front rails.

The rails are only retained by quite short housings into the side pieces. I decided to inject animal glue into the joints and clamp. Using a 1.5mm drill bit and choosing an unobtrusive location I drilled into the joint until I felt the drill hit a void. Animal glue was injected via syringe and needle into the joint and the sides clamped, *photo 8*.

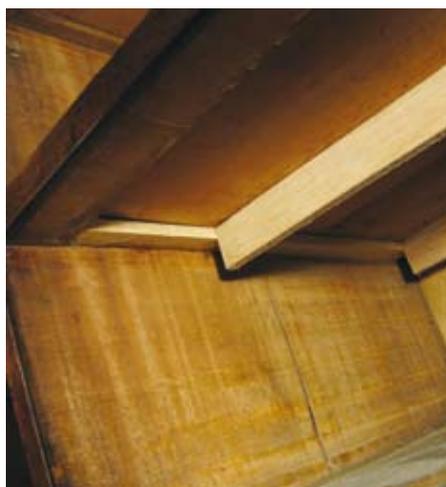
An issue probably related to the loose side joints was a missing kicker on one of the housings between the dust boards and the side. This was shown by the dust board dropping in its housing, thus increasing the slackness of the drawer, and was corrected by fitting a 25mm-wide piece of oak into the housing below the dust board. The piece was glued and held using sprung lathes, *photo 9*.

9 Kicker being glued in place; sprung lathes hold it in place

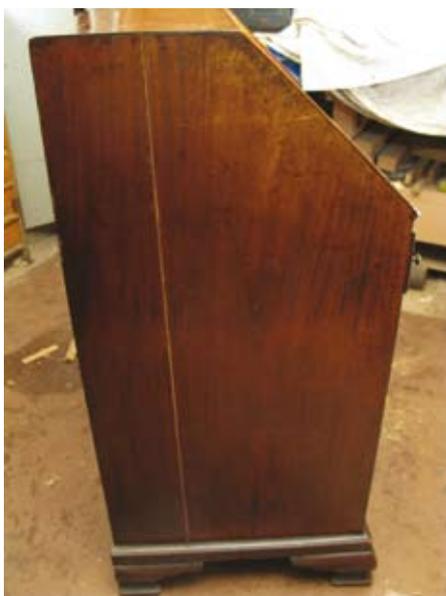
The left side had a vertical fairly straight split from top to bottom where the boards had parted.

10 Vertical fillet fitted to left-hand side

After cleaning any debris and wax from the opening a fillet of mahogany was planed up to fit, catering for the slight taper from top to bottom. The fillet was also tapered slightly in width to gently wedge into the split. The fillet was glued and tapped home, leaving a small amount standing proud to be removed with block plane and scraper after the glue had set, *photo 10*.

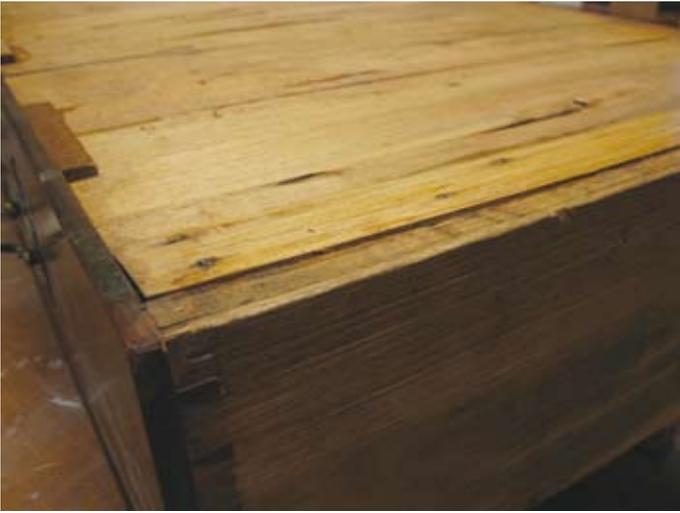
Because the drawer sides were only 7-8mm thick and the bottoms were much thicker than that, there was considerable wear and break up at the bottom of the sides. To remedy this, a previous restorer had nailed some pine runners to the bottom, *photo 11*. The pine had worn to allow the nails to excavate grooves in the runner boards, *photo 12*, causing the drawer stops to wear wide grooves in the bottoms, *photo 13*.

**11** *Worn and damaged drawer sides and nailed runner*

To remedy these problems I decided to fit oak fillets on the dust boards and to replace the bottoms of the drawer sides in order to provide good running surfaces for the drawers and lift them up to prevent wear to the bottoms.

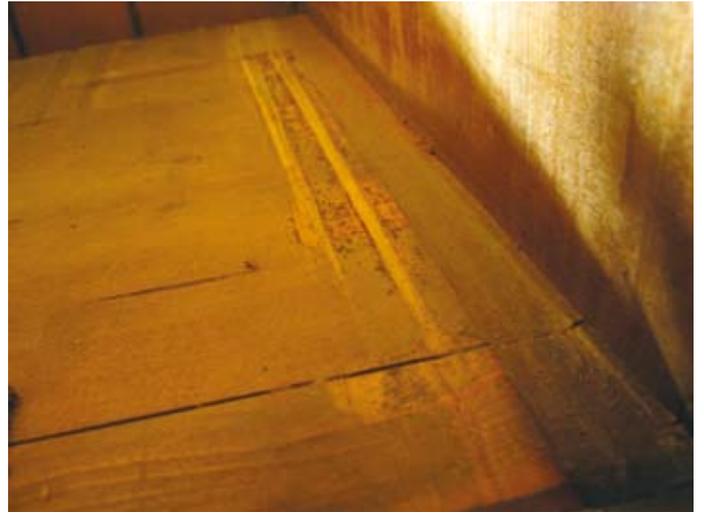
**12** *Grooves worn in dust boards by drawer runners*

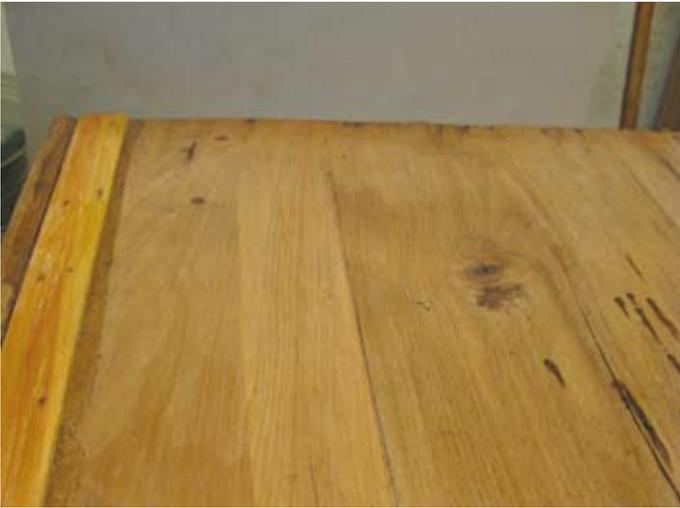
**13** *Damage to drawer bottoms from rubbing on stops*

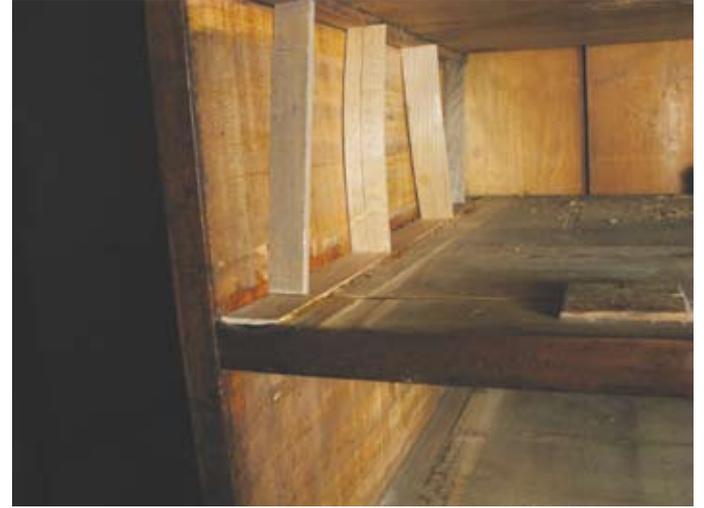
**14** *Fillet glued in place on dust boards using sprung lathes*

Using a shoulder plane a groove was excavated next to the carcass side. To ensure a clean edge to the groove, a marking knife was used to cut the fibres at the edge, using the plane edge as a guide for the knife.

The groove was deepened until a flat bottom was achieved, about 3mm, and a 3mm fillet was glued into the groove and held using sprung lathes, *photo 14*.

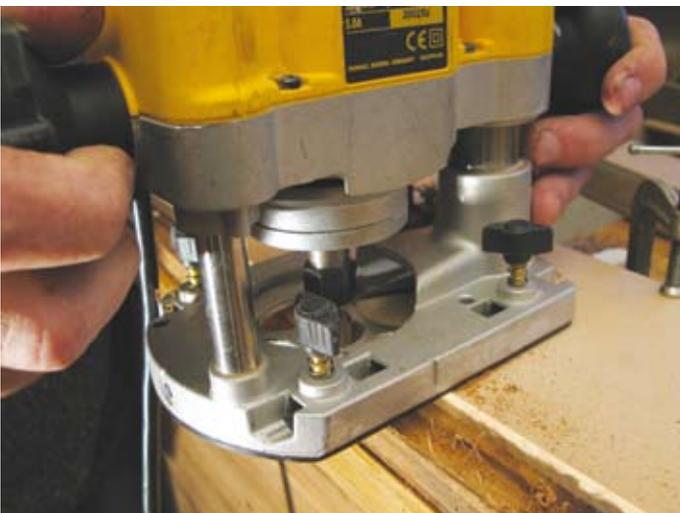
**15** *Cutting bottom of drawer sides with router collar bearing against MDF straightedge*

The repair to the drawer sides required the removal of the worn or broken bottom parts, leaving a clean line for fitting a new piece, achieved by using a router with guide collar running against a straightedge of 9mm MDF clamped to the drawer side so that the edge was parallel with the top edge.

The cut was made with the collar bearing against the MDF, *photo 15*. The depth of cut depended on the amount of damage to the side, in effect cutting the side in line with the underside of the drawer bottom.

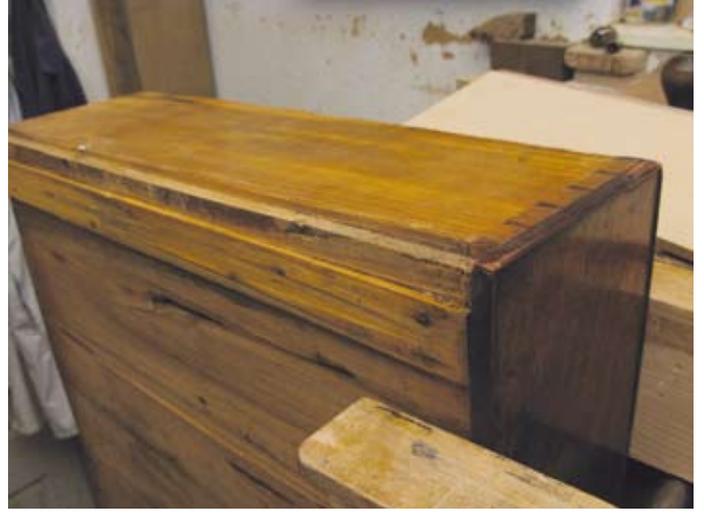
A couple of the sides had damage higher up which required a shallower cut to remove an L-shaped area, *photo 16*.

**16** *L-shaped area removed from bottom of badly damaged drawer side*

Oak pieces were used to replace the cutaway sections and rebated pieces were machined, marginally oversize to allow for trimming to fit, to fit the cutaways. After gluing up the drawers were fitted.

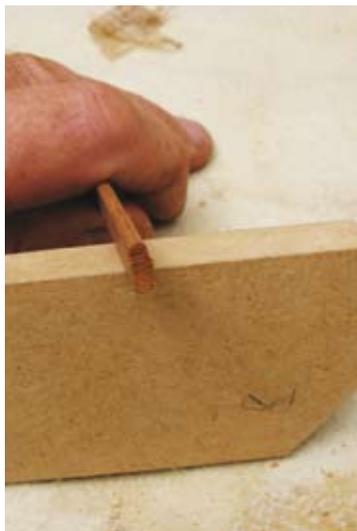
The 3mm thickness of the cockbead on this piece made it more prone to damage and the lower ends had almost no bead left. The rounding was formed using a block plane and abrasive paper, *photo 17*.

**17** Replacement cockbead

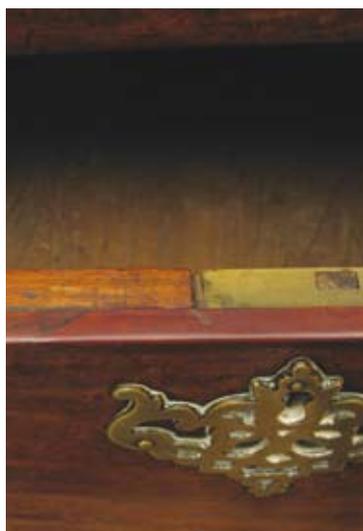
**18** Cockbead repair around lock after refinishing

Damaged areas were removed and new bead spliced in, *photo 18*. I mitred the corners by making a jig from stock cut at 45° and clamped to a saw hook, *photo 19*.

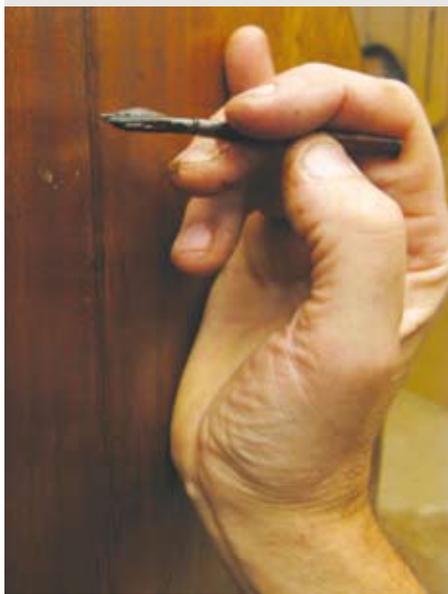
**20** Colouring with a quill

Final colour matching was now possible using spirit stains and earth pigments mixed in a thin dilution of button polish and meths applied with a quill, *photo 20*.

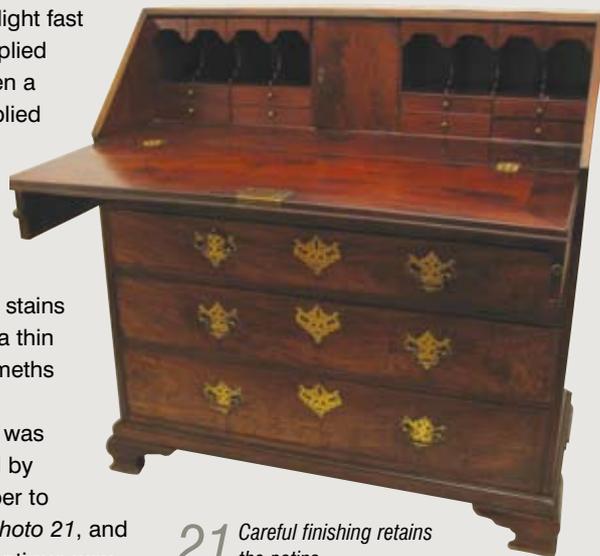
**21** Careful finishing retains the patina

A coat of thin button polish was applied with the quill followed by more applications with a rubber to blend with the background, *photo 21*, and an application of mahogany antique wax
